# Road- Stream Crossing Assessments

February 2024

# Woodbury Assessment Results

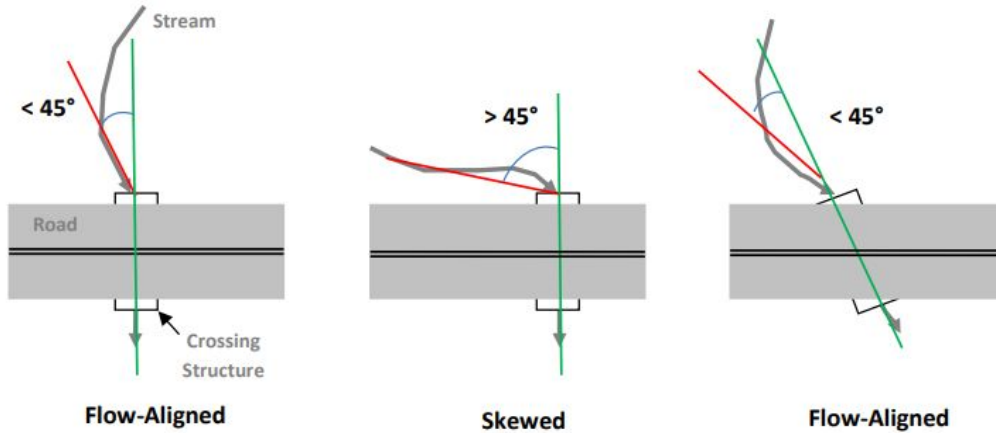
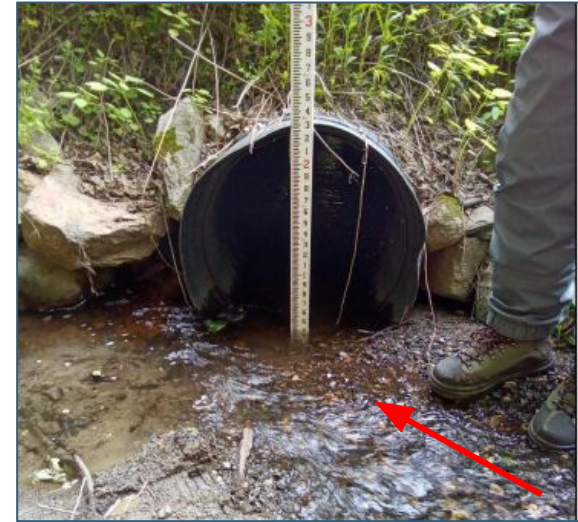
White Deer Rock Rd & unnamed stream off Cat Swamp Pond, Woodbury

\*Skewed alignment can result in scouring around the culvert inlet (see above - scour on left side of inlet)

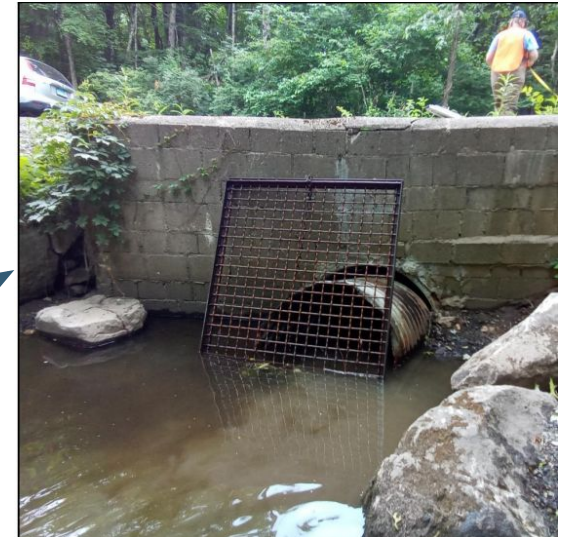
**Church Hill Rd &  
unnamed stream off  
East Meadow Brook,  
Woodbury**

**Bankfull width: 15.5ft**

**Inlet width: 3ft**

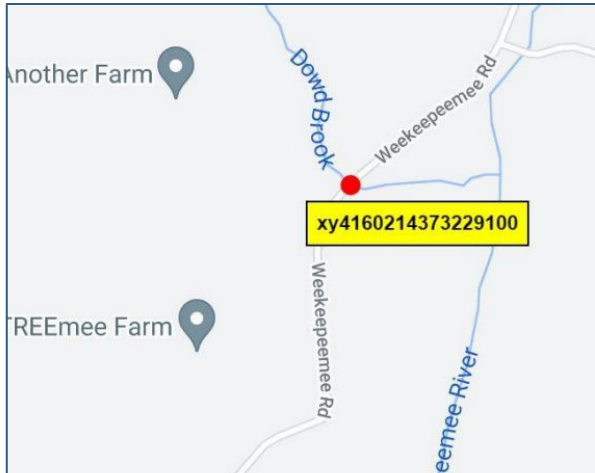
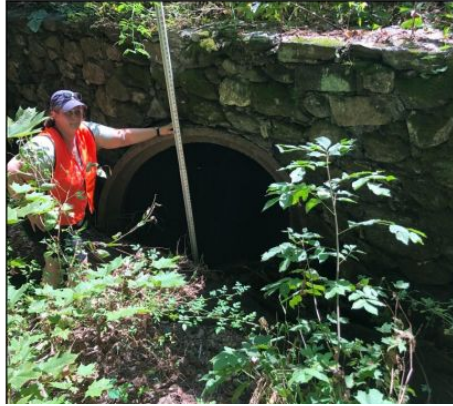
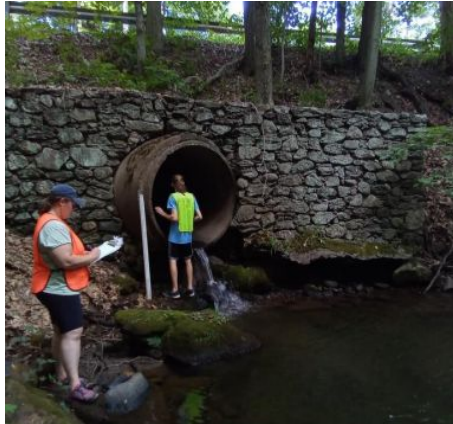
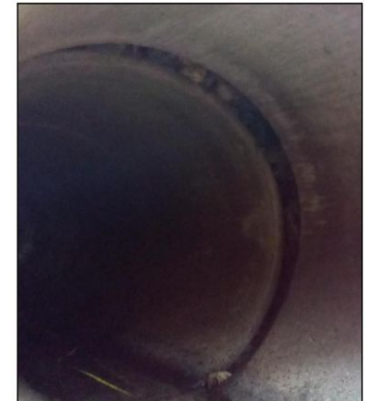
# Weekeepeemee Rd/Dowd Brook

Barrier Evaluation: **Severe Barrier**

Crossing Condition: **Poor**

NAACC Aquatic Passability Score: **0.00**

AOP: **No AOP**

- The stream is flowing under the culvert.
- Moderate sediment deposition was noted before the culvert inlet.
- The headwall at the inlet is leaning.
- The culvert segments have separated
- Severe constriction
- Large tailwater scour pool at outlet caused by freefall onto cascade outlet
- Culvert is not flow-aligned

**\*Outlet drop to the water surface: 2.9 ft**

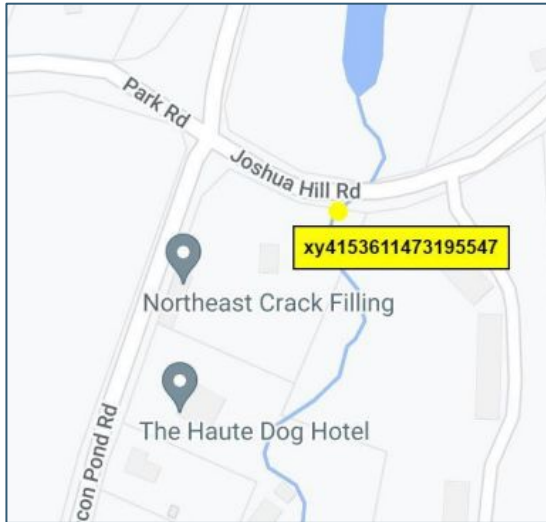
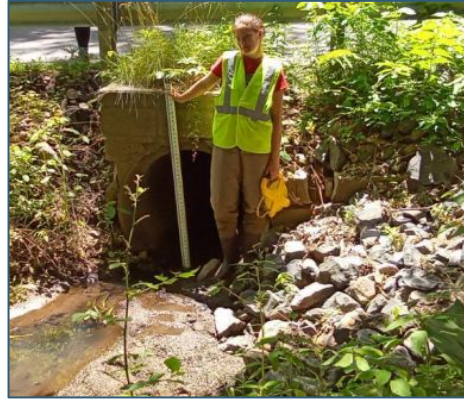
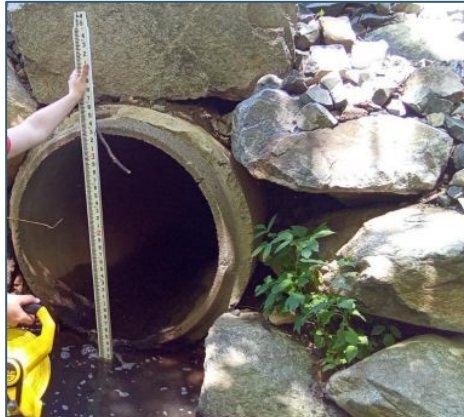
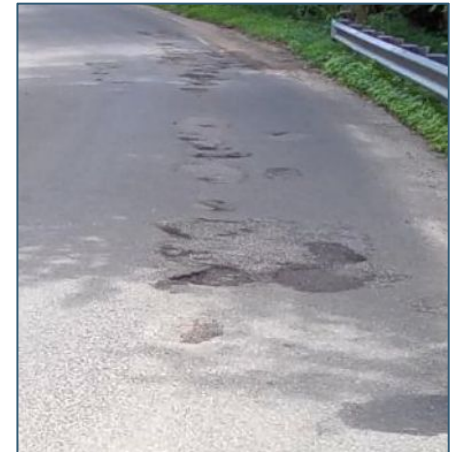
# Joshua Hill Rd/Unnamed Stream

Barrier Evaluation: **Moderate Barrier**

Crossing Condition: **OK**

NAACC Aquatic Passability Score: **0.45**

AOP: **No AOP**

- It appears that the stream may overtop the roadway in large rain events.
- Riprap is present around the culvert inlet
- The concrete headwall shows signs of deterioration
- There is a large tailwater scour pool at the outlet due to freefall (.1 ft drop).

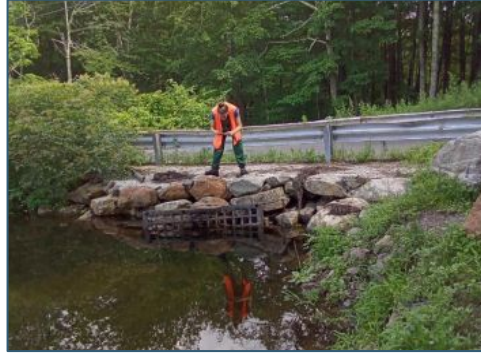
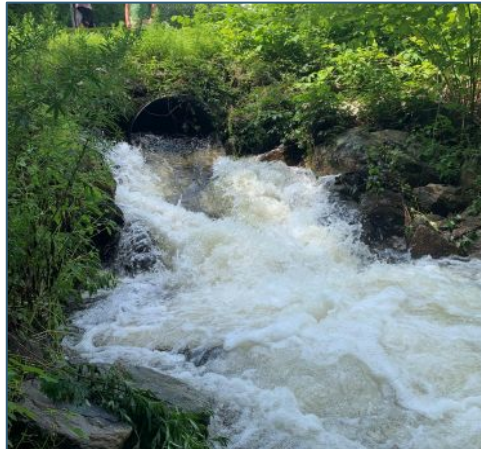
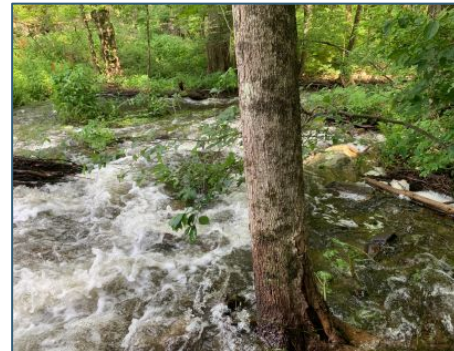
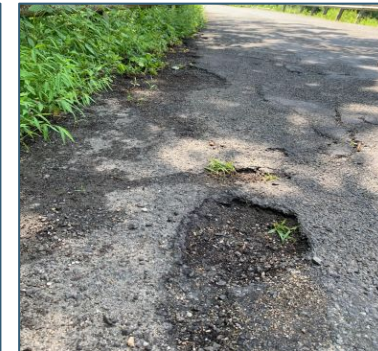
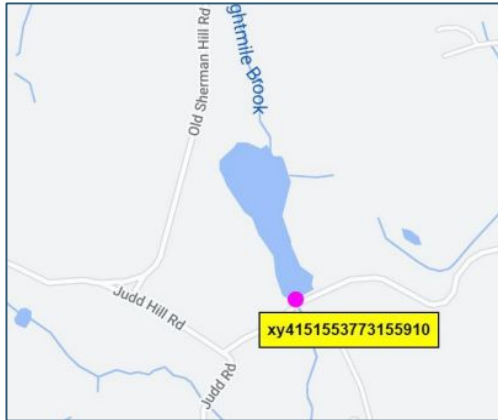
# Judd Hill Rd/ Eighthme Brook (Kelly Pond)

Barrier Evaluation: **No Score - Missing Data**

Crossing Condition: **OK**

^ No score can be calculated because inlet is obscured

- Plant material is caught in the beaver grate at the culvert inlet resulting in a moderate debris/sediment barrier.
- Severe constriction
- Water can be seen flowing downstream from under the road, 140 ft east of the culvert outlet.
- ^A 1979 Dam inspection report by the Supt. of Dam Maintenance noted two culverts at Judd Hill Rd, so this flow could be the result of a collapsed second culvert.
- There is increasing development downstream
- The road above the culvert exhibits damage.
