# Road- Stream Crossing Assessments

February 2024

# Woodbury Assessment Results

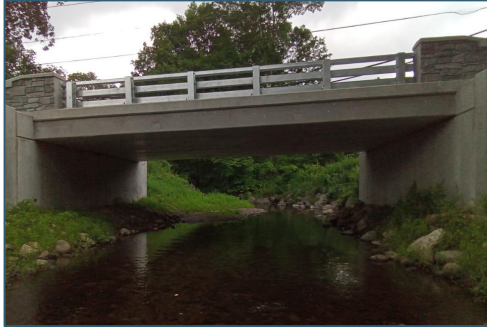
**NEW**  
Hazel Plain Rd &  
Sprain Brook,  
Woodbury

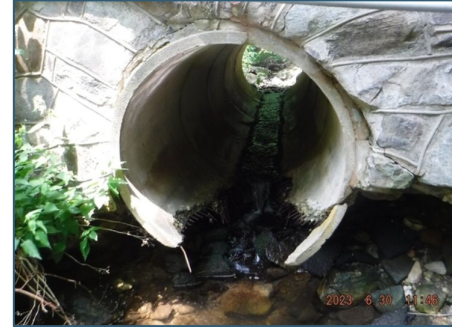
**POOR**  
Constitution Hill &  
unnamed stream,  
Southbury

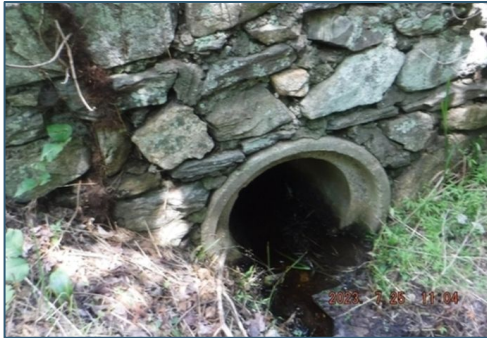
**OK**  
Curt Smith Rd &  
unnamed stream,  
Southbury

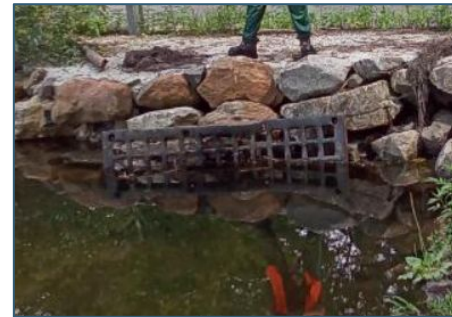
**UNKNOWN**  
Judd Hill Rd &  
Eightmile Brook,  
Woodbury

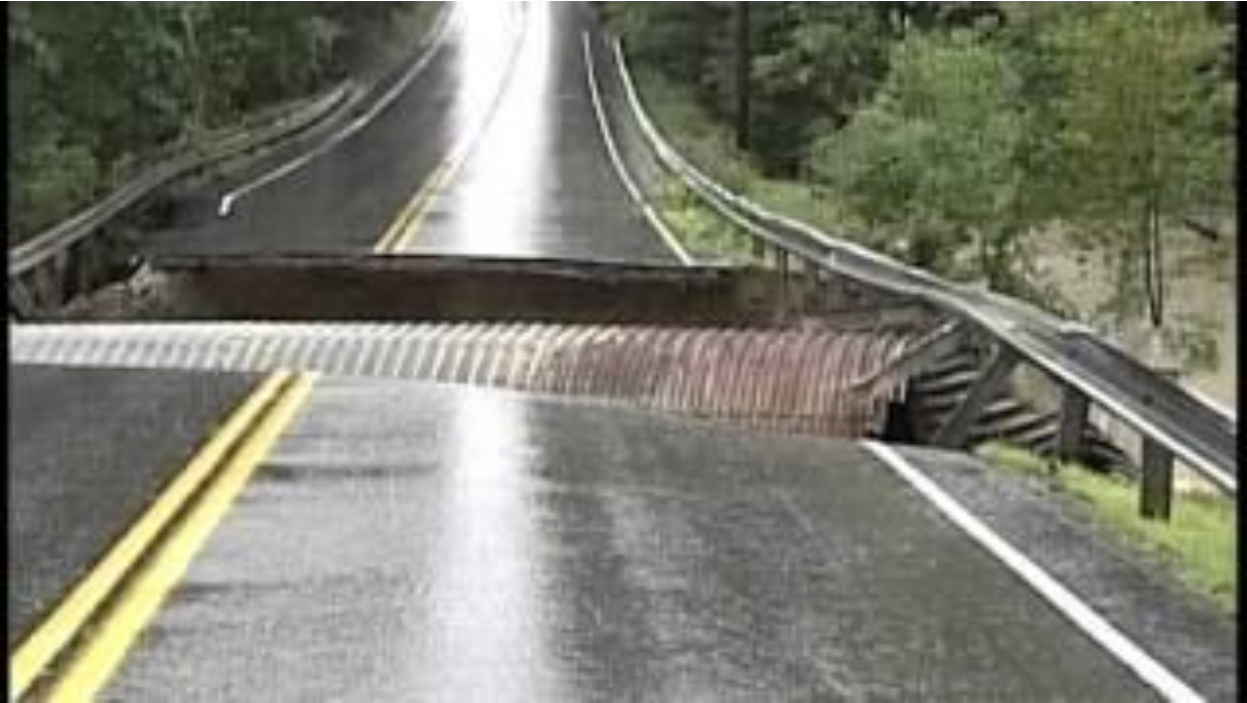
# Culvert Washouts

The impacts of flooding are intensified by aging and undersized stormwater infrastructure

**Follow-up  
evaluation  
(engineering survey  
of existing  
conditions to  
evaluate flood  
hazard risk / storm  
design capacity)**

**Develop engineering  
plans following  
climate resilient  
practices to handle  
project storm return  
volumes**

**Look to see if other  
projects are already  
being planned for  
these roads and  
integrate  
infrastructure  
improvements into  
existing plans**

**Seek funding for  
replacements – look  
to community  
resiliency grant  
pools and  
infrastructure grants**

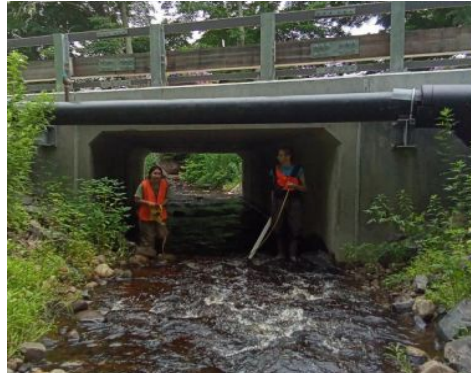
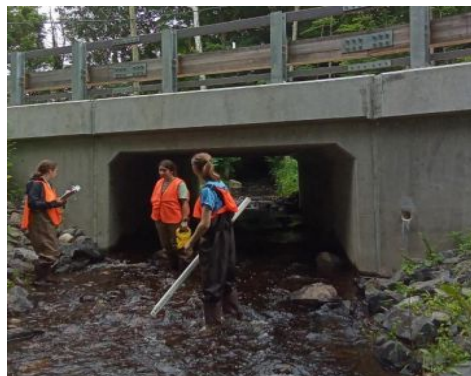
## Middle Quarter Rd & South Brook, Woodbury

Barrier Evaluation: **Insignificant**

Crossing Condition: **OK**

NAACC Aquatic Passability Score: **.97**

AOP: **Full AOP**

- The culvert spans the **full width of the active channel** and does not constrict the streamflow at typical flows.
- The inlet and outlet are both **at stream grade**, allowing fish and other aquatic organisms to pass through safely.
- **No scour** or need for additional armoring.
- The culvert being **flow-aligned** instead of skewed ( $>45^\circ$ ) reduces bank and culvert erosion and maintains proper streamflow direction and velocity.
- The **100% cobble substrate** at base of the culvert matches that of the stream and aids organism passage through the structure.
- **No physical barriers** restrict streamflow/aquatic organism passage.
- The stream's water **depth and velocity are maintained** through the structure.
